NEW DELHI, FRIDAY, APRIL 20, 2007/CHAITRA 30, 1929

“17 अक्टूबर, 2003 को मैसर्स सिंगरेनी कोलियरी कम्पनी लिमिटेड की कोयला खानों में हुई बड़ी दुर्घटना, जिसमें 10 लोगों की मृत्यु हुई, के संबंध में जांच अदालत की रिपोर्ट”

जांच न्यायालय का प्रतिवेदन

**S. O. 625(E).**— In pursuance of Section 27 of the Mines Act, 1952(35 of 1952) the Central Government hereby publishes, as Annex to this Notification, the following report submitted to it under Sub-section (4) of Section 24 of the said Act by the Court of Inquiry appointed to hold an inquiry into the causes and circumstances attending the accident which occurred on 17th October, 2003 in the collieries of M/s. Singareni Collieries Company Limited, more particularly in the Godavarikhani No. 8A Incline Mine of Ramagundam Region in District Karimnagar of Andhra Pradesh State.

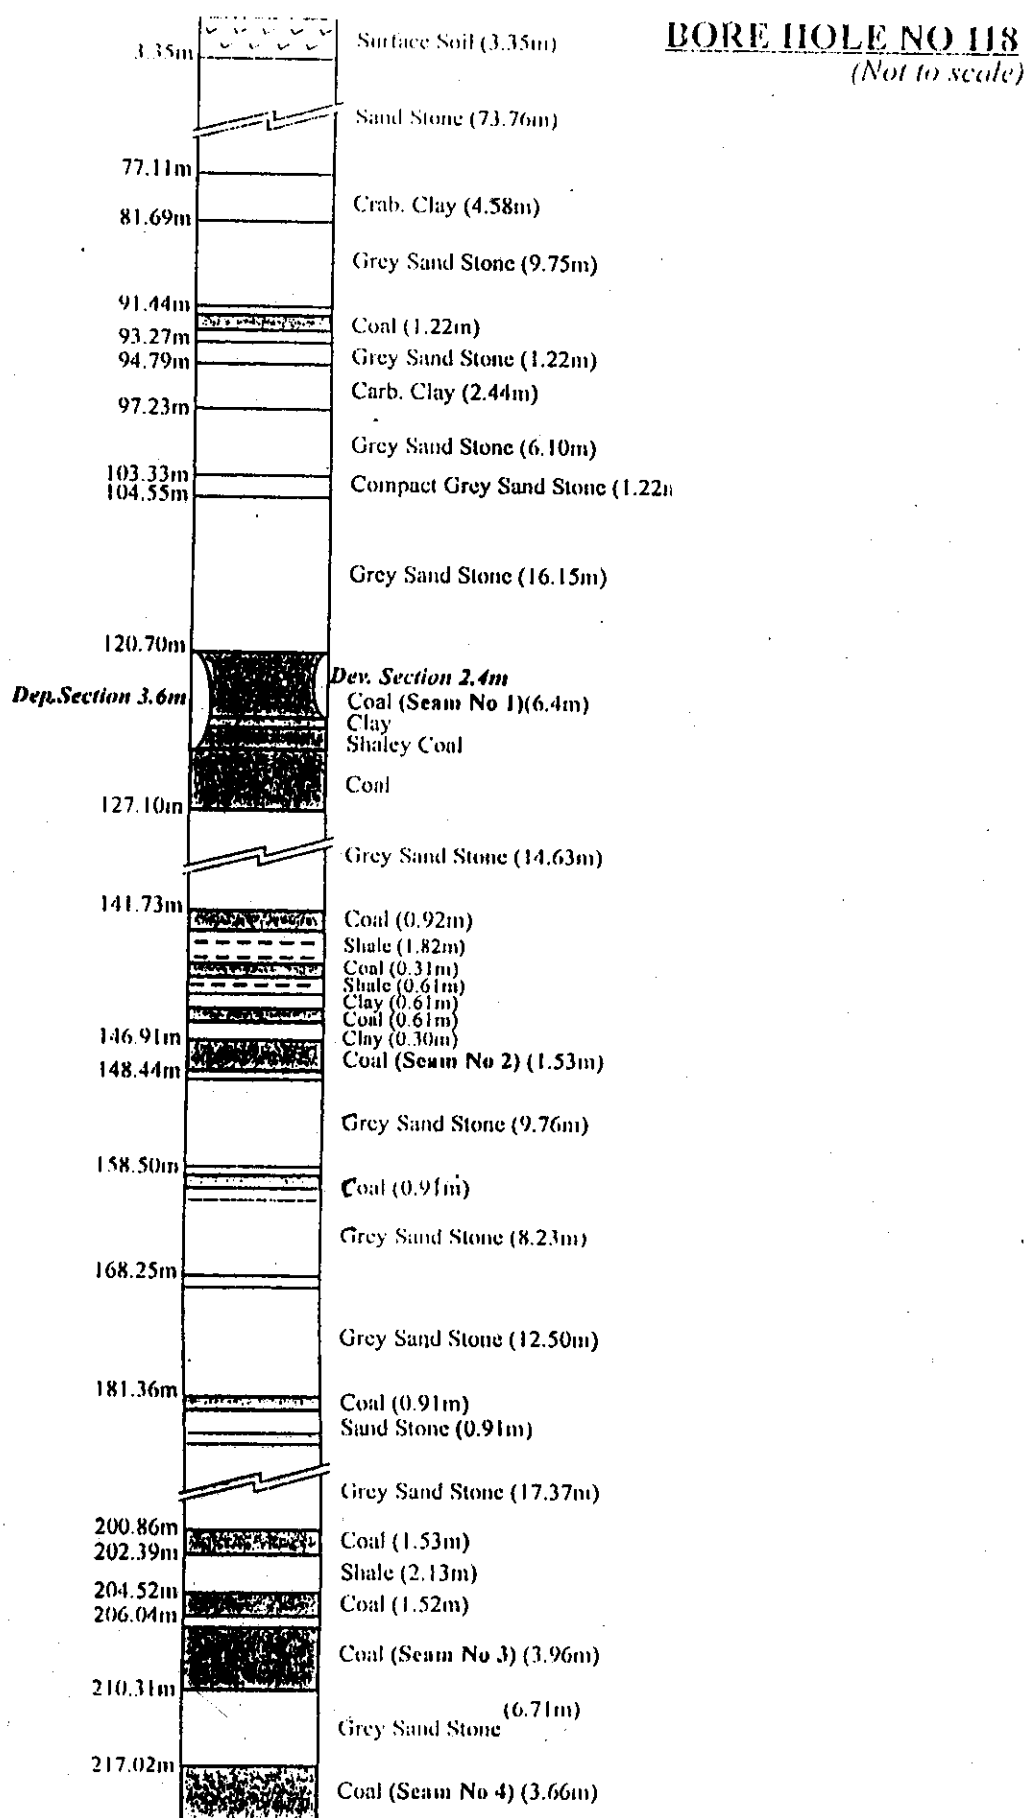
Fig 1: Section along Bore Hole No 118 showing different seams at GDK8A Incline, SCCL.

no. 1 has been extensively developed on bord and pillar method of mining. The seam no. 2 was earlier declared as non-workable, but it is now being developed. However, this seam is virgin below panel no. 46 B of seam no. 1. The bottom seam no. 3 was developed in two sections and proposed to be extracted by Blasting Gallery method. The solid parting between no. 1 and no. 3 seams based on borehole no. 118 located around 18D/44L is approximately 70 m. The different seams in the mine are depicted in Fig.1.

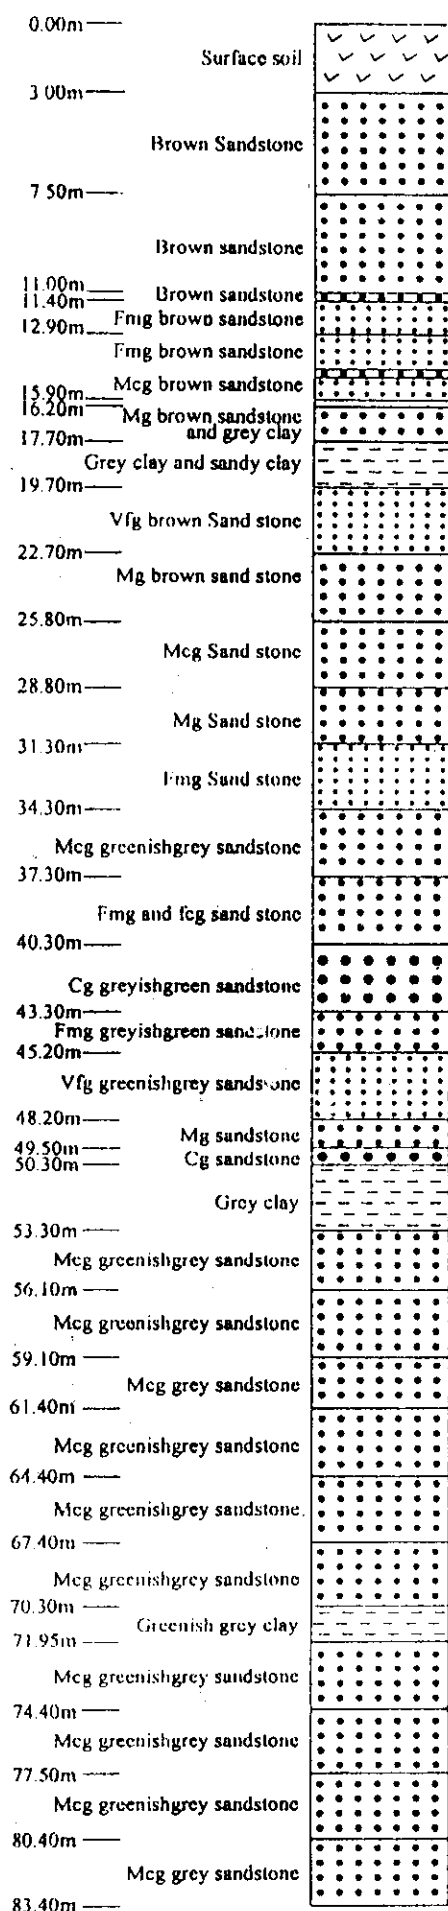
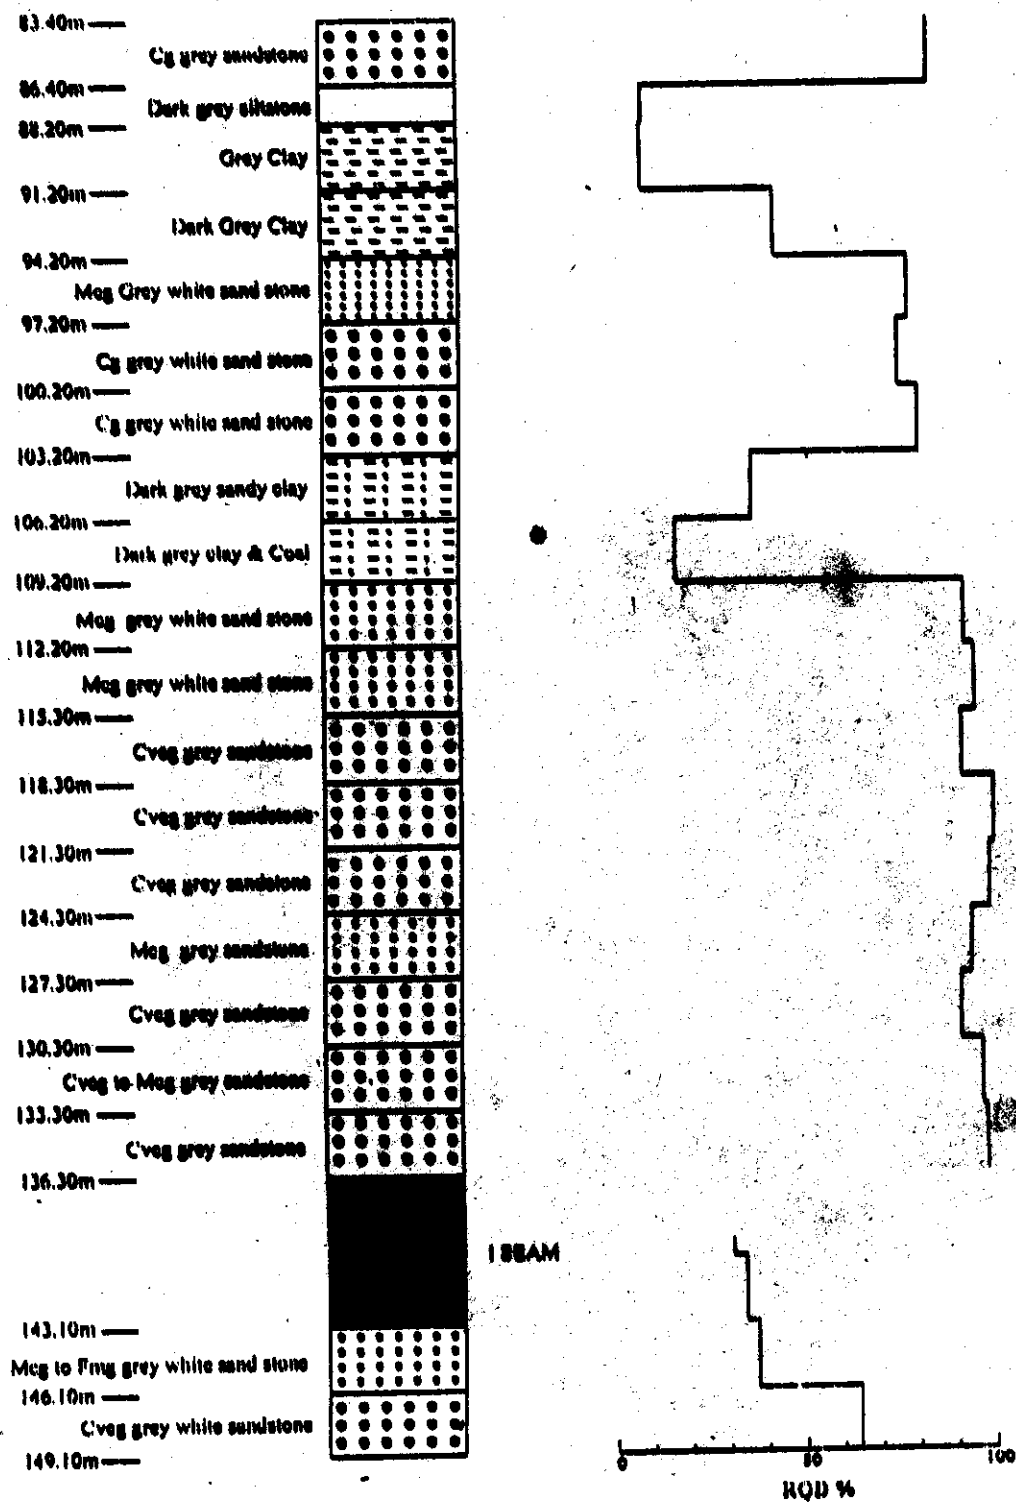
Fig 3: Section along Bore Hole No 1130, located at panel no 46B, where rock samples were tested for modelling purpose.

**BORE HOLE NO : 1150**  
**LOCATION : GDK-8A INCLINE**  
*(Not to scale)*

It was suggested to take out the rock samples by core drilling machine using triple-core barrel from the surface on panel 46 B site, to determine the physico-mechanical properties in the laboratory. The section of the borehole is shown in Fig 3. This borehole was located between 8 & 9 Dips and 52 & 53 Levels marked in Fig. 4. The physico-mechanical properties used in the numerical models based on tested data has been detailed in Table 3. During testing of the different rock samples, it was found that there was variation in different properties; therefore, for the simplicity an average value of the different types of the rocks have been taken. Here, Poisson's ratio of the different rocks tested in the laboratory were found varying widely. Therefore, Poisson's ratios were assumed to be 0.25 for the sandstone and 0.20 for the coal based on data available in literature. NIRM had determined CMRI Rock Mass Rating (RMR) for the immediate hard, pyretic sandstone and for soft white sandstone as 64 and 47 respectively. Similarly, for coal and shaly coal, CMRI RMR has been given as 47. These values have been converted into Bieniawski's RMR for the modelling purposes.

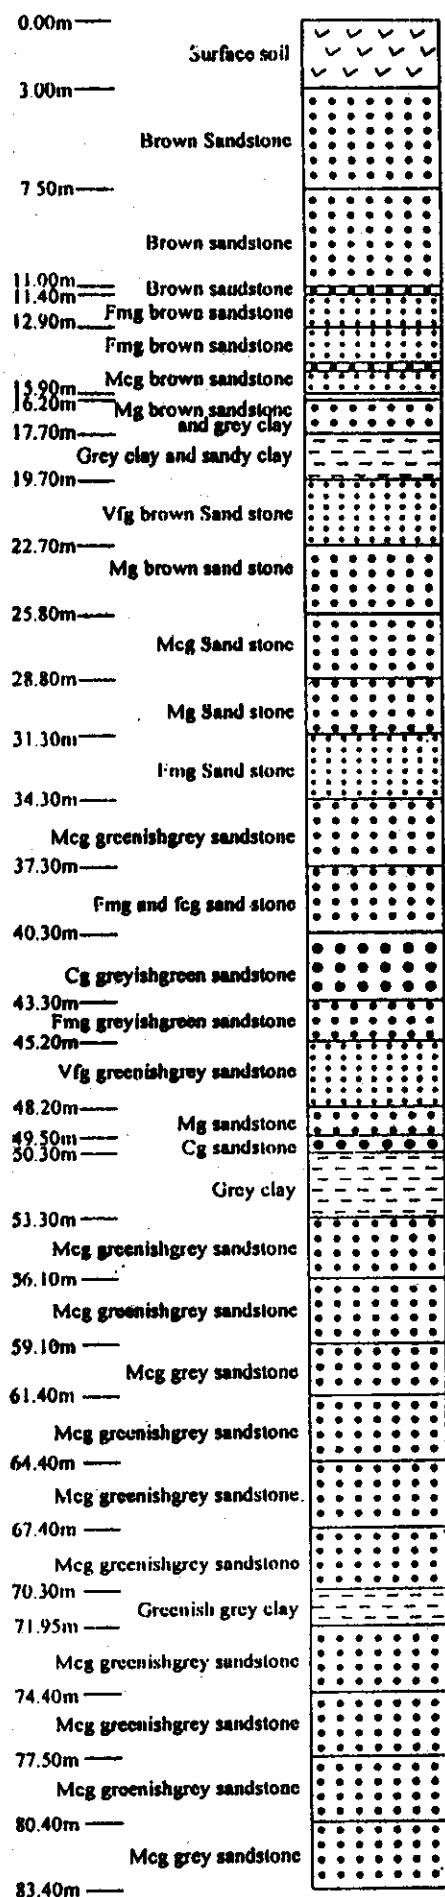
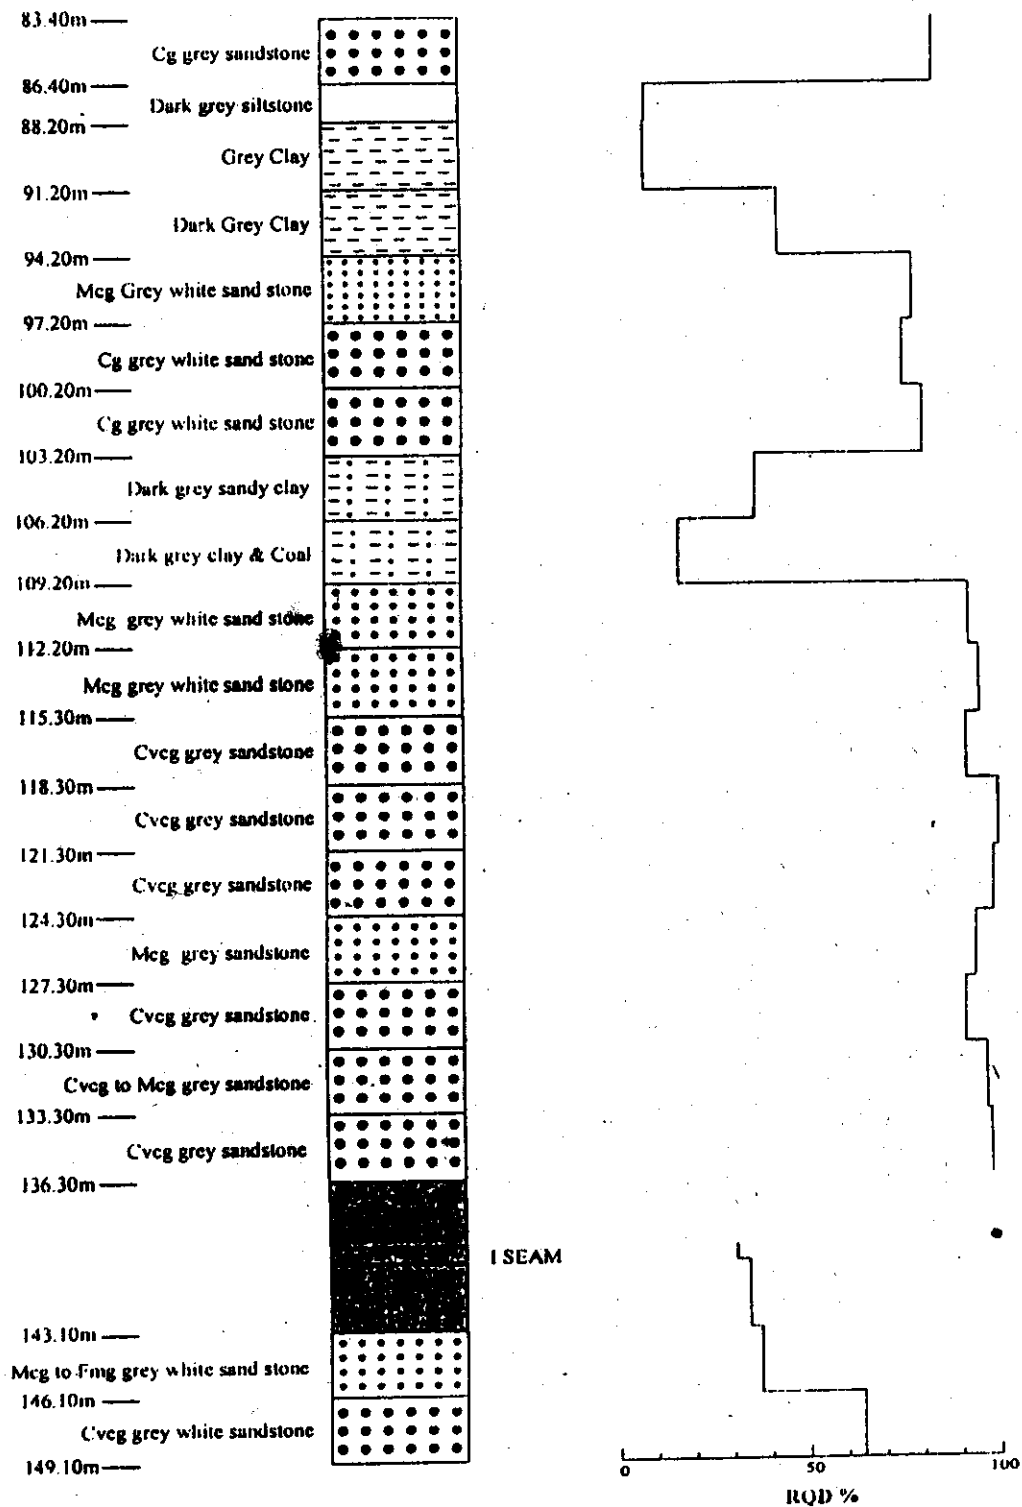
Fig 3: Section along Bore Hole No 1150, located at panel no 46B, whose rock samples were tested for modelling purpose.

**BORE HOLE NO : 1150**  
**LOCATION : GDK-8A INCLINE**  
*(Not to scale)*
